DELAWARE RIVER BASIN
POND RUN, MERCER COUNTY
NEW JERSEY

ASSUNPINK W.S. SITE
NO. 8 DAM
PHASE I INSPECTION REPORT
NATIONAL DAM SAFETY PROGRAM

NJ 00543

NAME OF DAM: ASSUNPINK W.S. SITE NO. 8

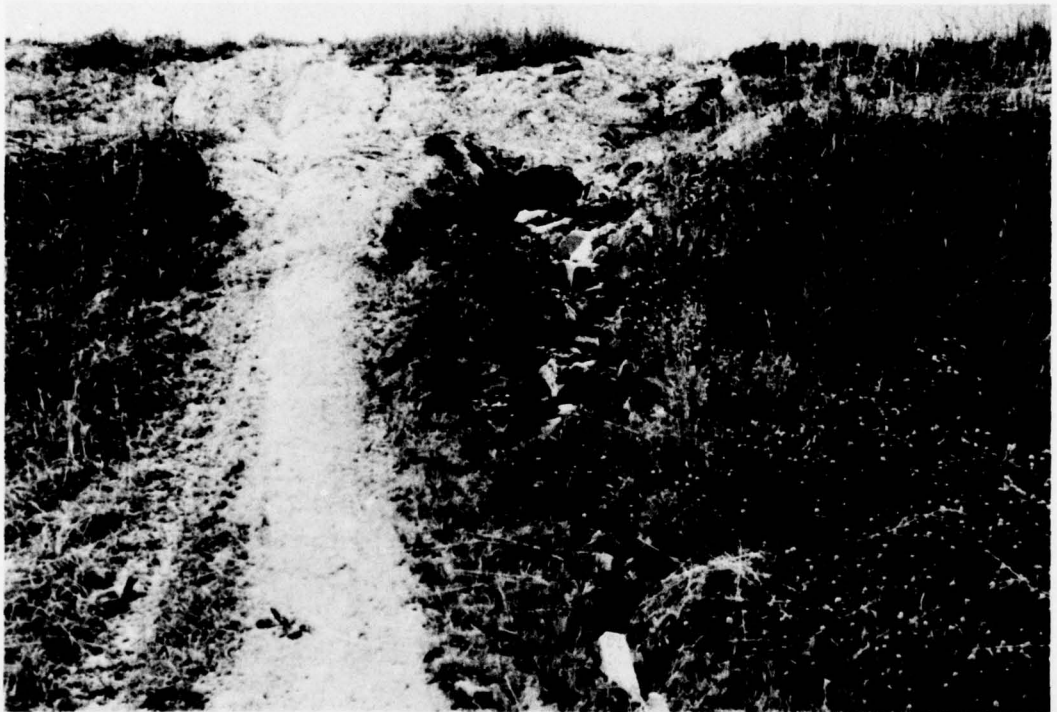
PHOTO 2

as shown in Photo 2, are present on the south cut slope of the auxiliary spillway. At this location, the steepness of the cut slope (as steep as 1.3:1 versus 2.5:1 shown on the "as built" drawings) has contributed to erosion. Other gullies, varying from one-half foot to one and one-half feet deep, were observed near the left abutment (Photo 1), at the impact basin and just upslope from the right abutment near a parking area. All gullies should be filled in and reseeded.

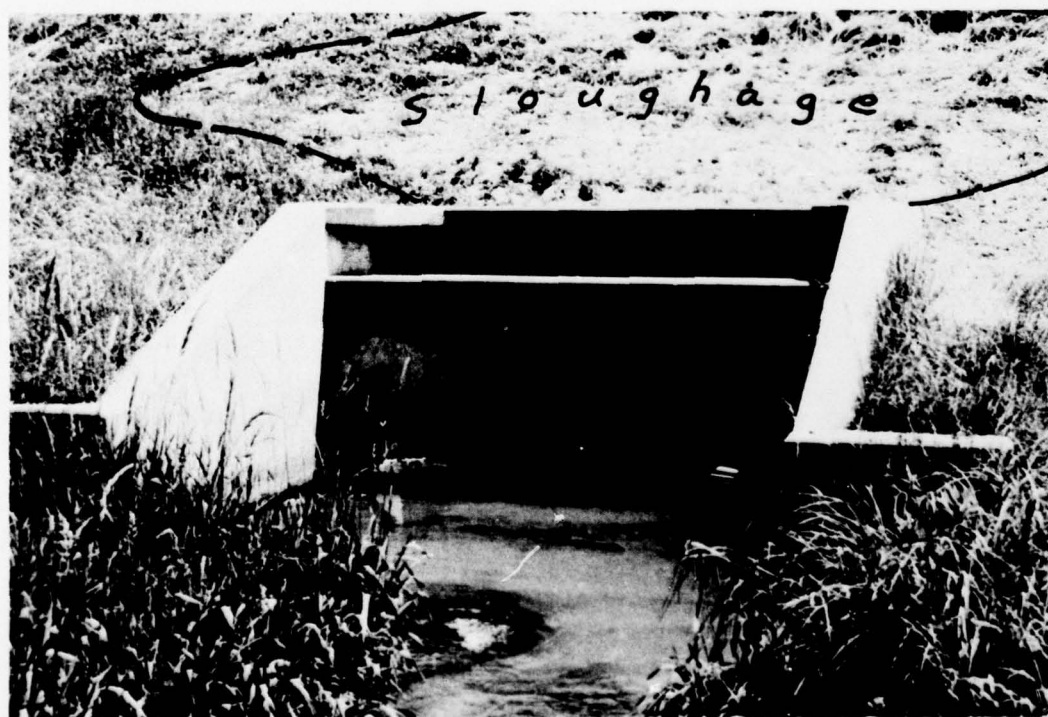
PHOTO 6

- b. Dam - During the visual inspection a slump or sloughage area was observed immediately upslope from the impact basin as shown in Photos 6 and 7. The slump or sloughage area was measured to extend 21 feet upslope from the impact basin and appeared to have a length of approximately 37 feet. The maximum displacement at the top of the slump or sloughage area was measured to be 22 inches. Soil exposed at the surface in this area was observed to be a medium-fine sand with some silt and a trace of gravel. Slopes in the slump or sloughage area were measured to be 2.3 horizontal to one vertical (2.3:1) or flatter. Small areas adjacent to the slump or sloughage were observed to be slightly eroded, but no seepage from this area or from any other portion of the dam slope or areas downstream could be found. A very small (one-half foot deep or less) gully extended down from the dam crest into the slump or sloughage area. Additional investigation, as discussed in Section 7, to determine the cause of the slope movement should be performed.

- a. Visual Observations - The presence of the slump or sloughage area located immediately adjacent to the impact basin may indicate that a serious deficiency exists in the embankment of this location. No slumps or significant sloughage was noted elsewhere on the dam. Although no seepage was observed from the embankment, some seepage or piping may occur during periods of high pool elevation in the area adjacent to the impact basin which may have caused the slump or sloughage.

- d. Necessity for Additional Investigation - Additional investigation is recommended to determine the cause of the slump or sloughage located immediately adjacent to the impact basin. If this slump or sloughage has been caused by seepage through the embankment during higher than normal pool elevations; future high reservoir levels may cause additional slumping and a seepage failure. A portion of the "Recommended Guidelines for Safety Inspection of Dams" which deals with seepage failure is presented in Appendix D for reference.

It is recommended that an investigation be conducted to determine the cause of the sloughage or slump adjacent to the impact basin and that appropriate corrective action be taken. This additional investigation should be conducted by a qualified engineer and should include the following:

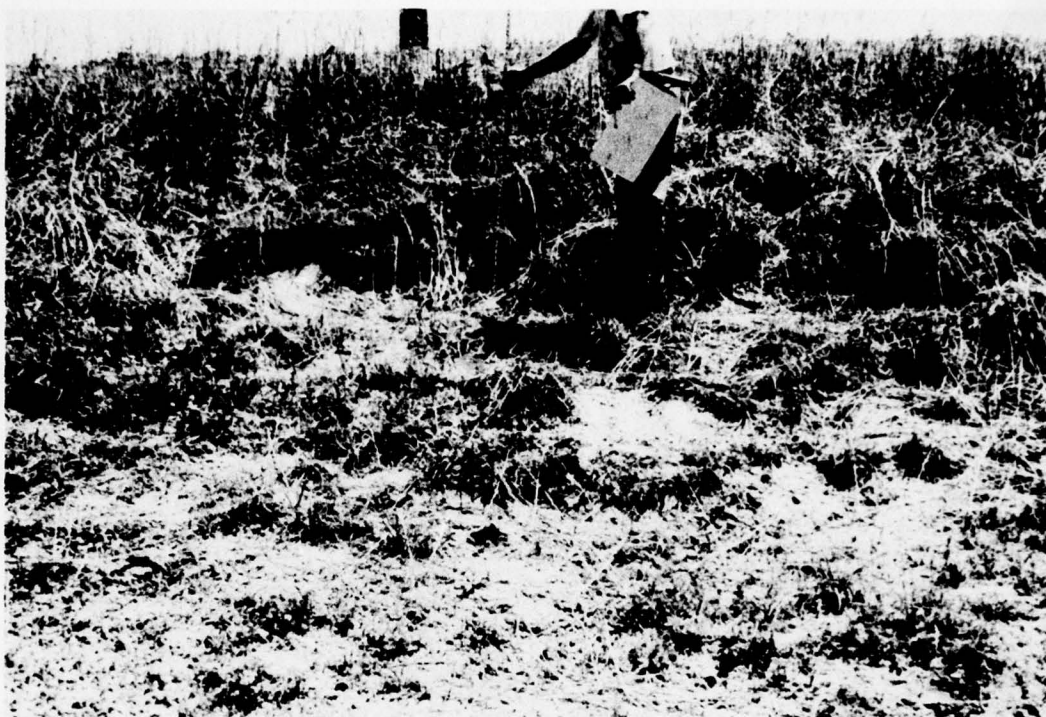
PHOTO 7

Photo 7 - Closer View of Slump or Sloughage Area (Maximum vertical displacement at top is approximately 22 inches.) - 23 June 1978

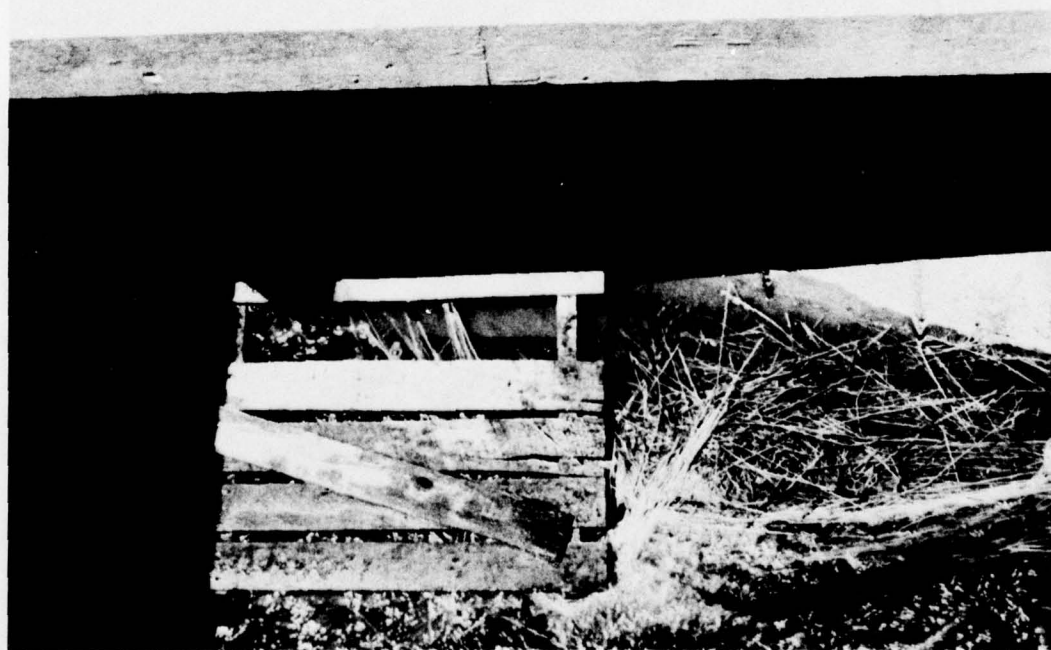
PHOTO 8

- c. Appurtenant Structures - At the time of the visual inspection, the riser low flow orifice trash rack was missing and some debris was partially blocking the orifice. The hand crank wheel for operating the gate valve was removed by the owner to avoid the possibility of vandalism and unauthorized operation of the gate. The impact basin was noted to be partially filled with debris which should be removed. In general; however, the riser, outlet pipe and impact basin forming the principal spillway appeared to be in good overall condition.

Photo 8 - View of Debris in Impact Basin looking Down From Top - 23 June 1978

- a. Dam - The slump or sloughage observed and described in paragraph 3.1.b. does not appear to immediately endanger the structural stability of the dam at normal pool. However, further investigation, as discussed in Section 7, should be performed to determine the cause of the sloughage and to devise appropriate remedial measures.
- b. Appurtenant Structures - The missing orifice trash rack and animal guards on the toe drain outlets, although not a serious problem, should be reinstalled to insure the proper operating condition of these features. The accumulation of the debris at the riser and in the impart basin is hindering the functioning of the principal spillway. Consequently, the debris should be removed.
